S-59
Robert H. Jones House
Upper Fairmount
Private

Maryland Historical Trust State Historic Sites Inventory Form

Survey No. S-59

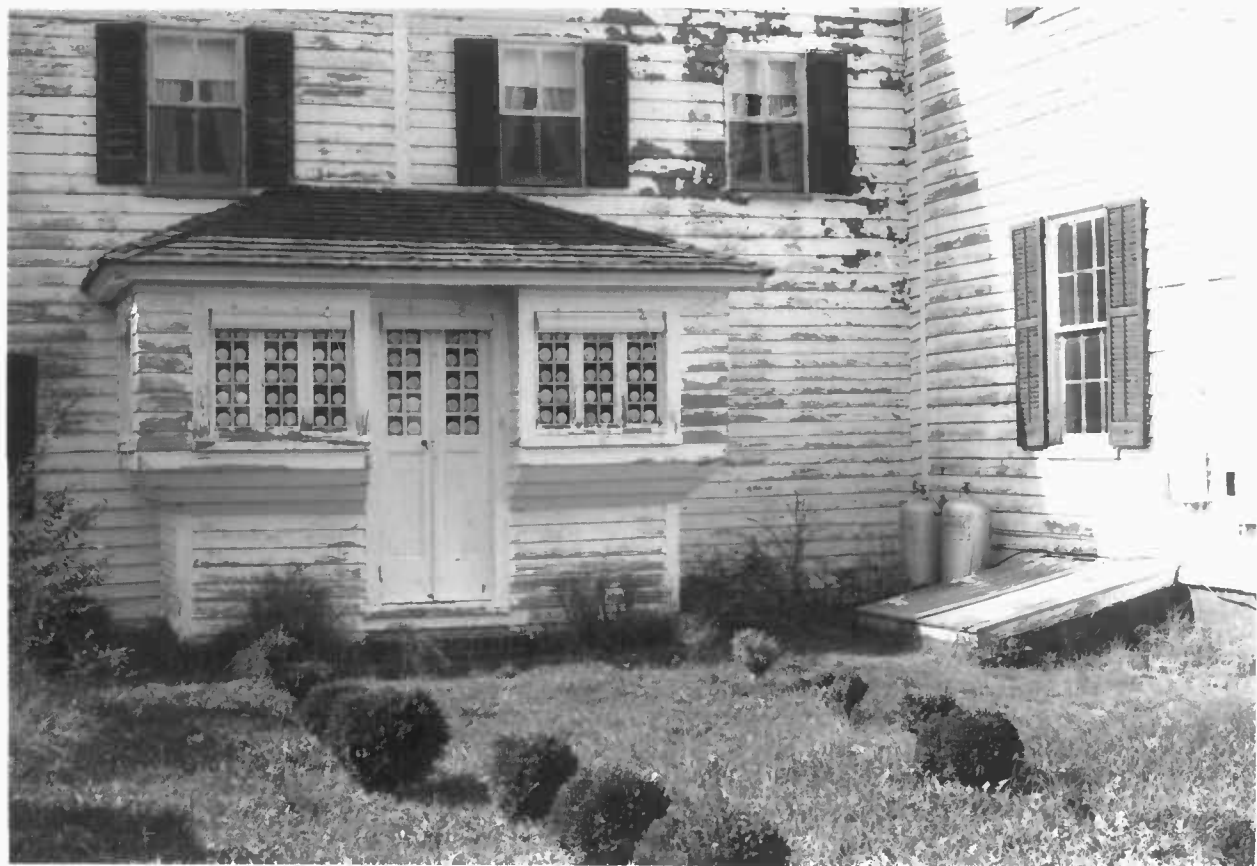
East Elevation

The Robert H. Jones House, standing in the middle of Upper Fairmount, is the largest and most architecturally distinctive dwelling to survive in this small rural village. In addition, a two-story porch formerly stretched across the main facade. A two-story service wing extends to the rear and is highlighted by a two-story porch on the west and a butler's pantry on the east.

Butler's Pantry

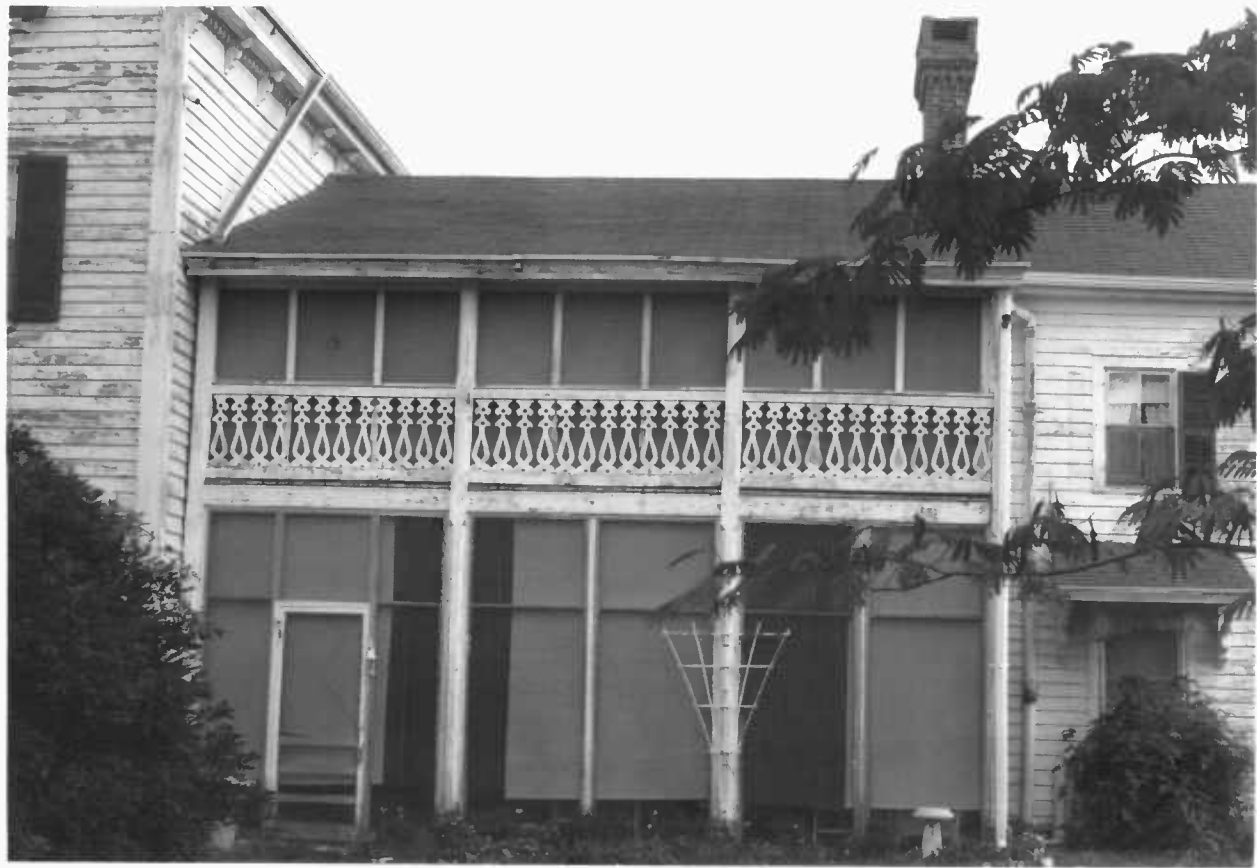
Robert H. Jones House
Upper Fairmount, Md. Somerset County
West Porch
Photographer - Paul Touart - 10/83
Neg./Md. Historical Trust

The two-story service wing was built in at least three stages; evidenced by several seams in the weatherboards. A brick chimney rises from the center of the wing, and a brick stove stack protrudes from the gable end. A two-story porch covers part of the west side of the service wing and is distinguished by sawn balusters. Located on the east side is a small c. 1900 hip roofed butler's pantry with access outside through a center double door. Multipane windows fill the top half of the walls to each side.

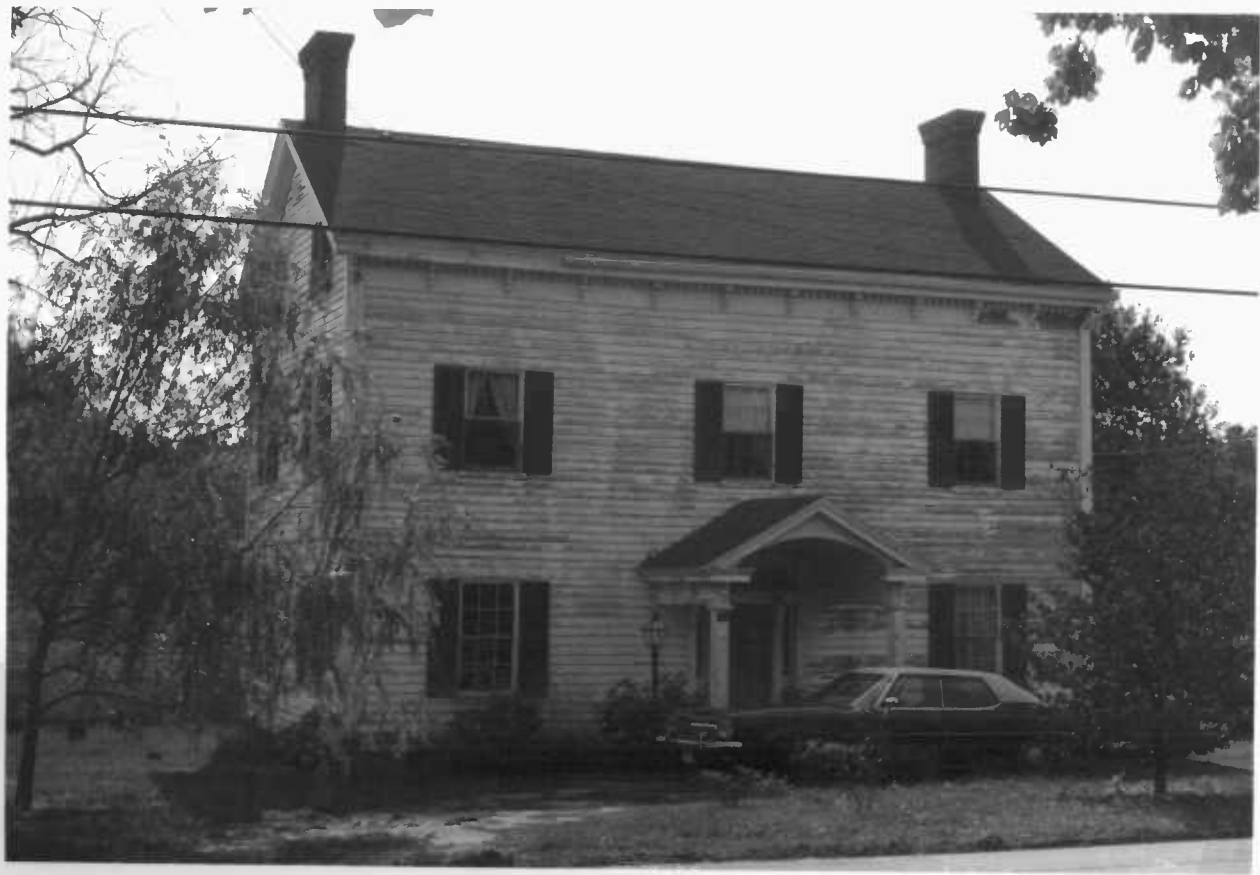
North Elevation

The north facade is three bays across with a center entrance and one-bay porch, which is flanked by 6/6 sash windows. A heavily molded four-panel front door is framed by an exuberant surround and bordered by etched-glass sidelights and transom. Covering the entrance bay is a single bay gabled porch which was built with materials taken from the previous stretched across the facade. A missing two-story porch is the reason for the abnormally large wall space between the second floor windows and bracketed eaves. In fact, the center second floor window once was a door that opened onto the porch. All the windows on the main facade as well as the rest of the house are flanked by louvered shutters.

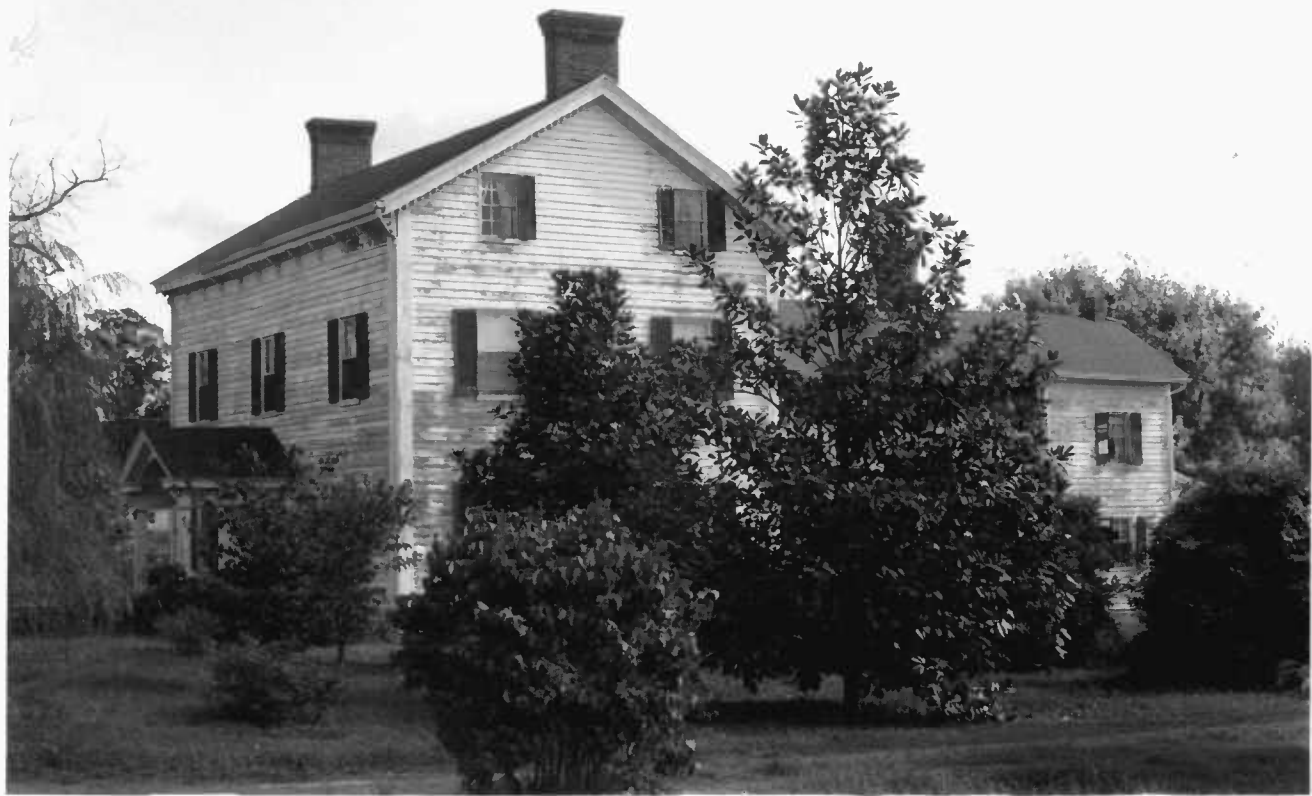
Robert H. Jones House
Upper Fairmount, Somerset Co. Md.
Northwest Elevation
10/83 Paul Touart, Photographer
Neg/Md. Historical Trust

Each gable end has two windows on each floor as well as an interior end brick chimney with dentiled cap. The bracketed eave extends around the gable ends along with the back of the house.

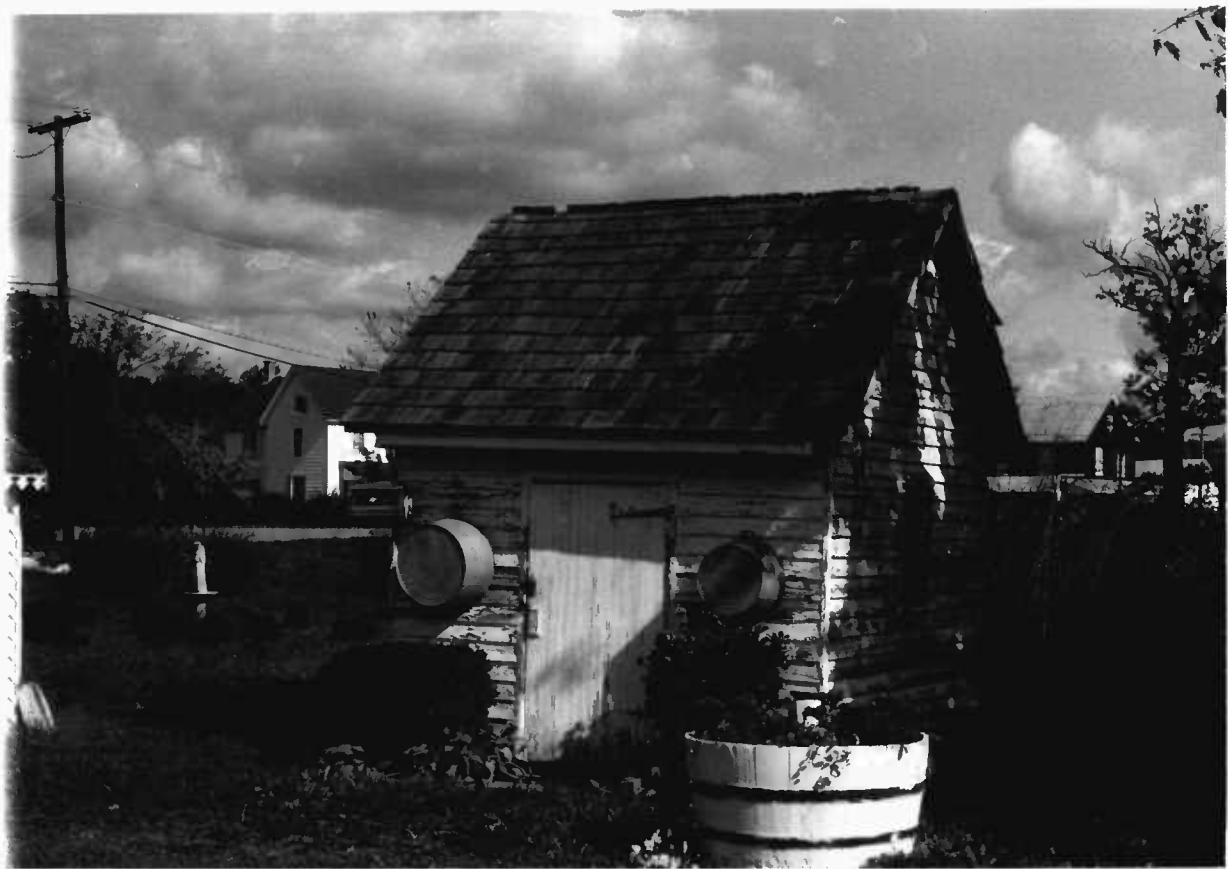
Elevation of Smoke House

Standing behind the house are two 19th-century outbuildings; a weatherboard frame smoke house and an octagonal gazebo. The smoke house rests on a brick foundation and is covered with a medium sloped wood shingle roof. The front wall is pierced by a board and batten door with strap hinges. A louvered vent is located on each side wall. The interior is completely blackened.

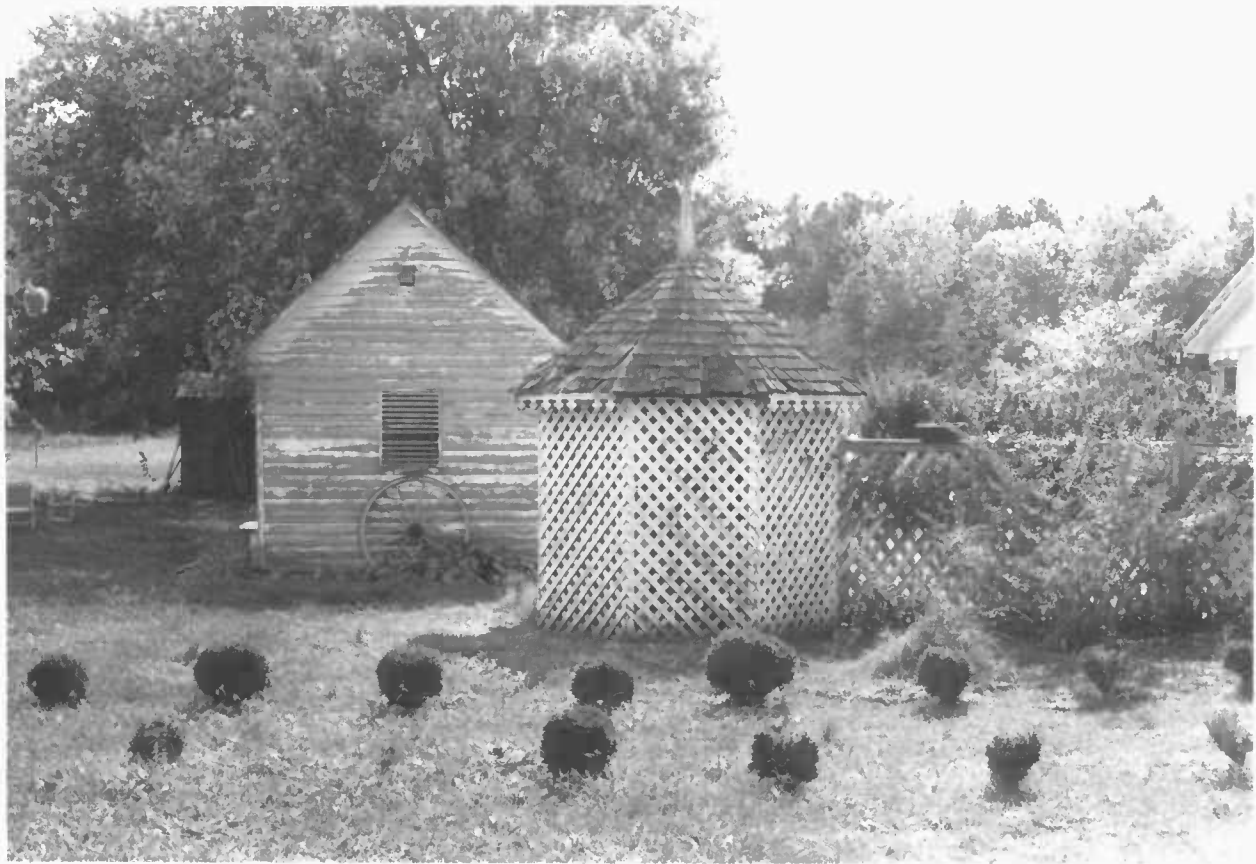
Robert H. Jones House S-59
Upper Fairmount, Md. Somerset County
Gazebo and Smoke House - North Elevation
Photographer - Paul Touart - 10/83
Neg./Md. Historical Trust

The diagonal lattice gazebo stands next to the smoke house. The roof is covered with wood shingles and topped by a wooden spire. The base of the roof is trimmed with decorative sawn work.

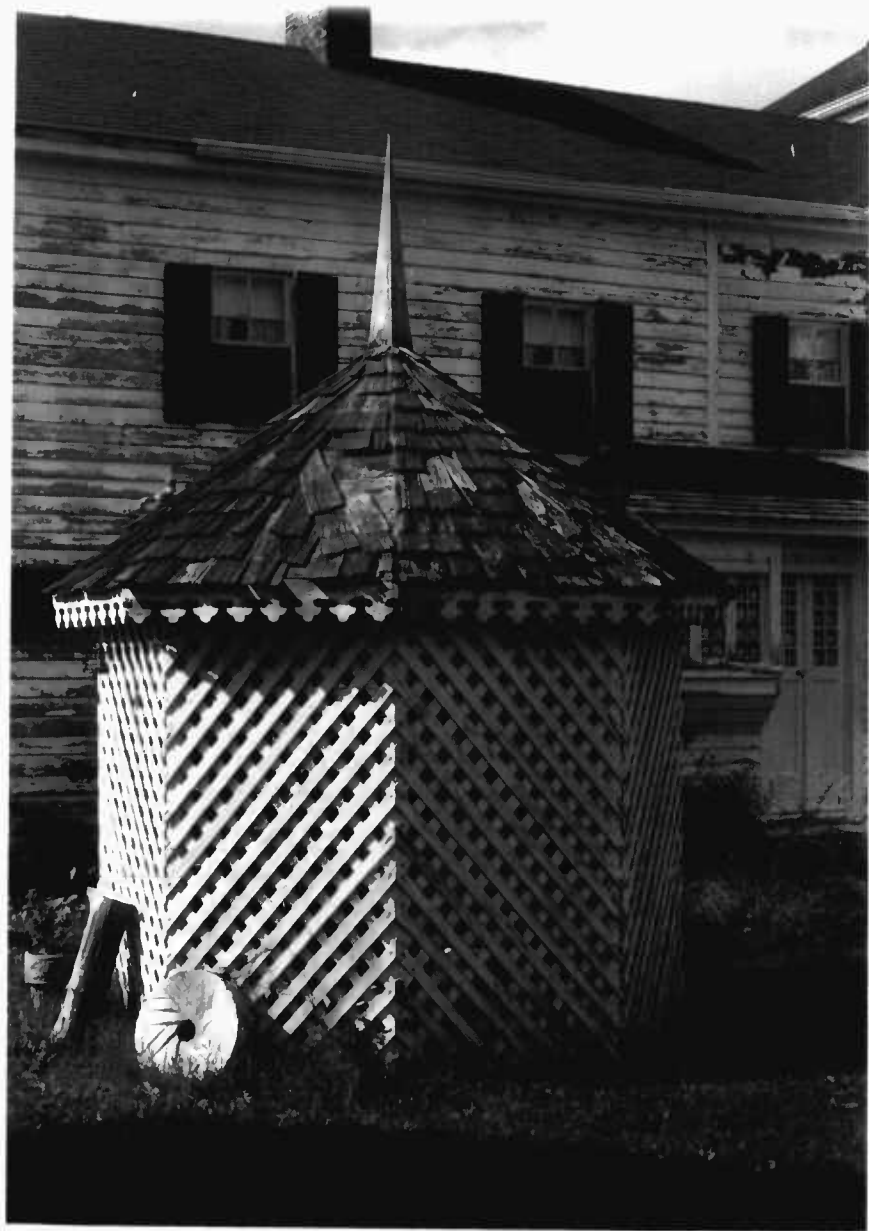
S-59

Robert H. Jones House
Upper Fairmount, Somerset County
Entrance - North Elevation
Photographer - Paul Touart - 10/83
Neg./Md. Historical Trust

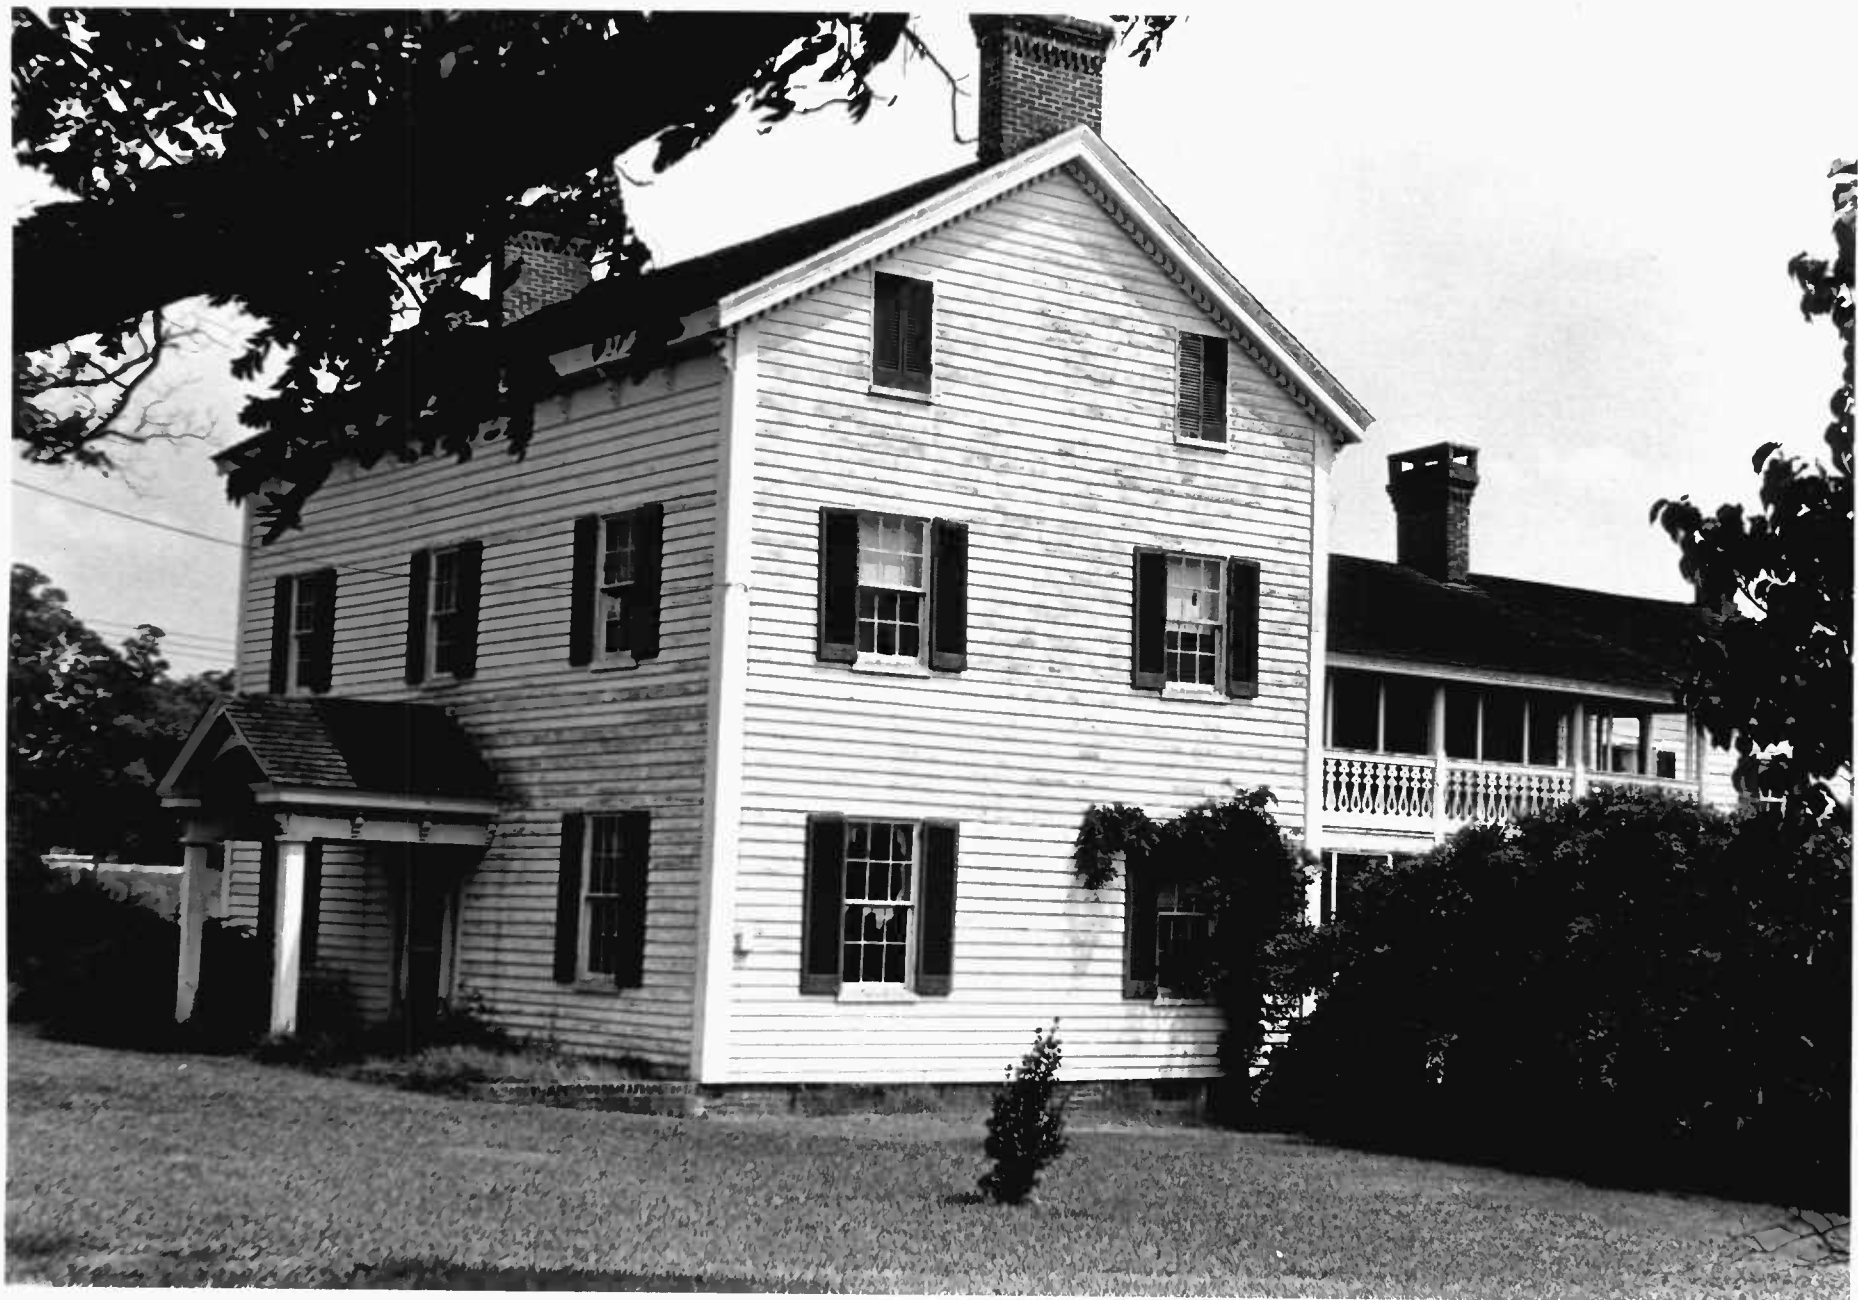
S-59

Elevation
ographer - Paul Touart - 10/83
Md. Historical Trust
